QUEENSLAND BUILDING AND
CONSTRUCTION COMMISSION

TIMBER DECK AND BALCONY CONSTRUCTION

TIMBER DECKS AND BALCONIES

THE ASCOT COLLAPSE

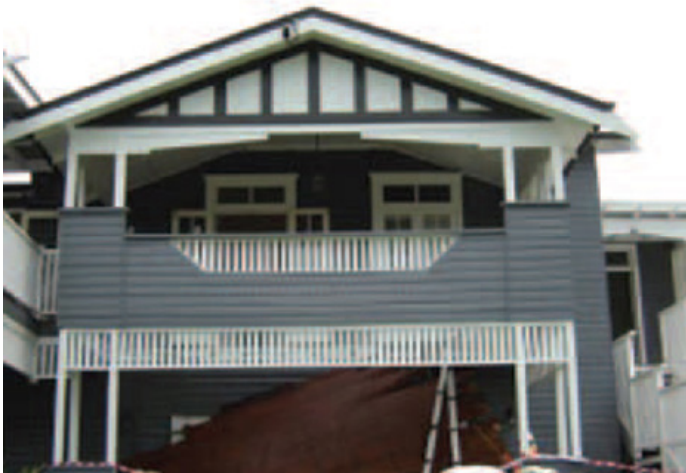
Ascot residence subject to balcony collapse

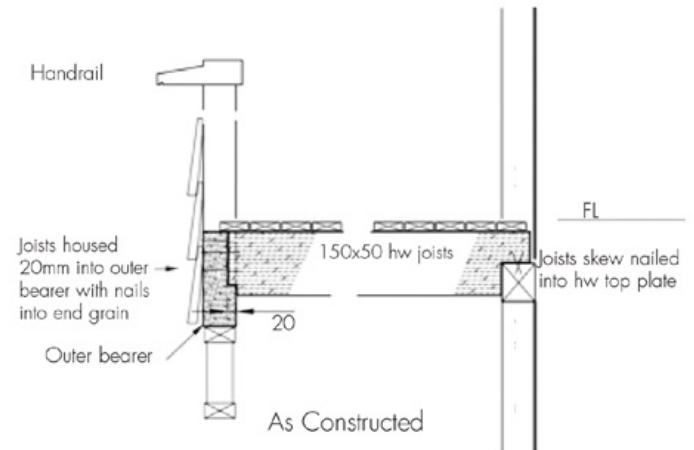
The front balcony measured approximately 6.5 metres x 2.75 metres and appeared to be part of the original dwelling. Deck joists were approximately 145 x 55 hardwood fixed at approximately 500mm centres and were cogged into a check-out housing in a deck bearer running across the front of the balcony and cogged over a floor plate where attached to the main residence. The joists were skew nailed to the bearers and many of the nails showed evidence of significant corrosion.

Cross-section of Ascot deck as constructed.
(Drawing provided with generous permission of Peter Wright RPEQ)

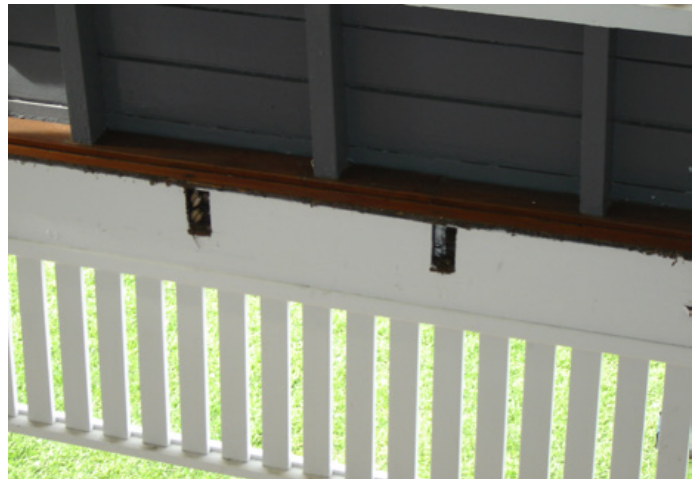
Cause of collapse - Over a long period of time the external balcony bearer deflected outward due to the inadequate restraint provided by the nail fixings into the bearers. Corrosion of the nails may have contributed to the inadequate restraint. As the bearer deflected outward the joists began to be displaced from their housing in the bearer and this is evidenced by paint on the ends of joists and into the bearer housings.

Housings in the bearer

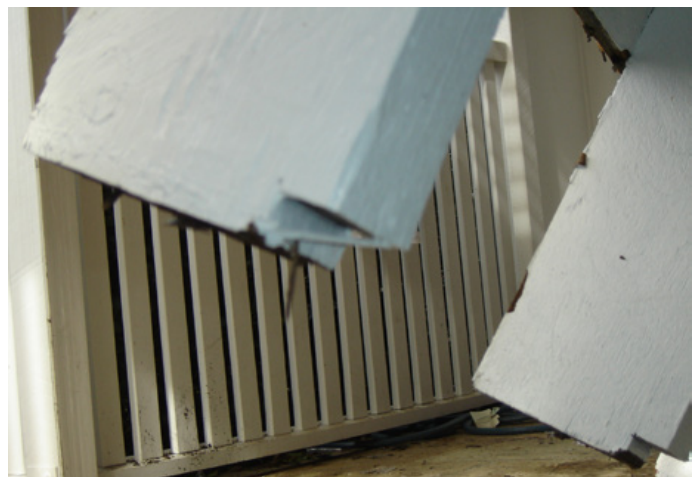
Paint clearly evident inside the cog in the joist

In fact paint witness marks indicate that on a small number of joists the full depth of cog measured to be approximately 18 to 20mm had disengaged from their housing due to an outward deflection of the main bearer.

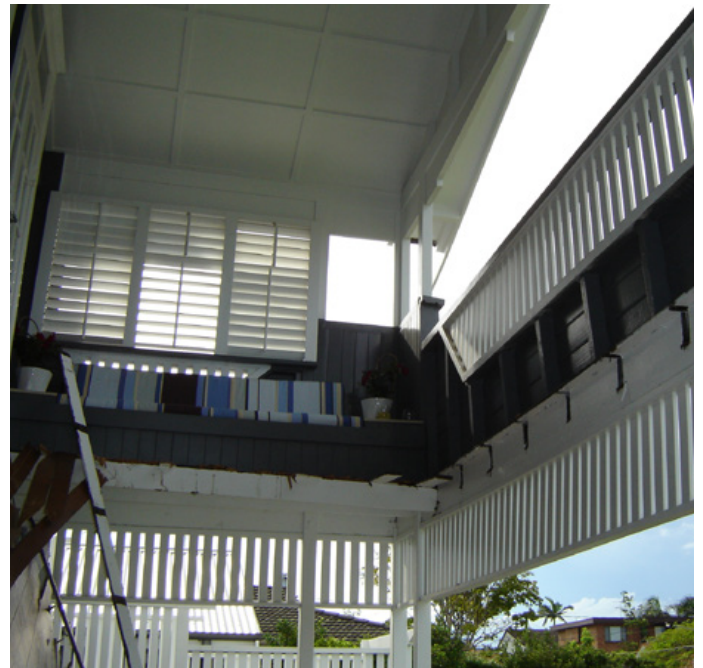
View of external bearer support

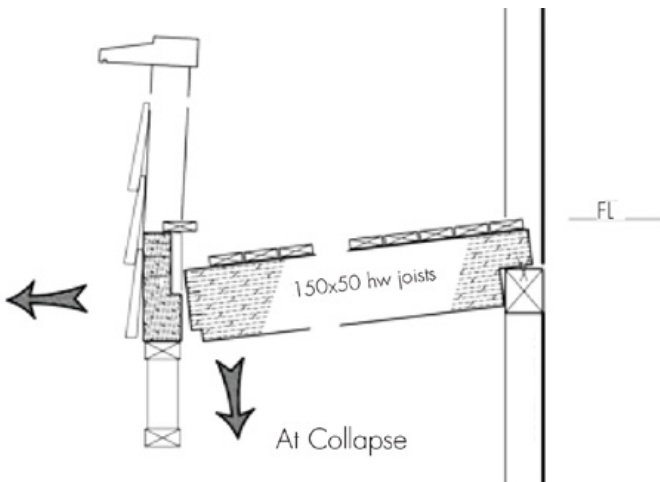
Once one or two floor joists became disengaged they started a progressive collapse of adjacent floor joists due to a probable outward thrust on the floor bearer as the joists rotated downwards, allowing adjacent joists to pull out of their housing in the bearer.

Cross-section of Ascot deck at time of collapse.
(Drawing provided with generous permission of Peter Wright RPEQ)

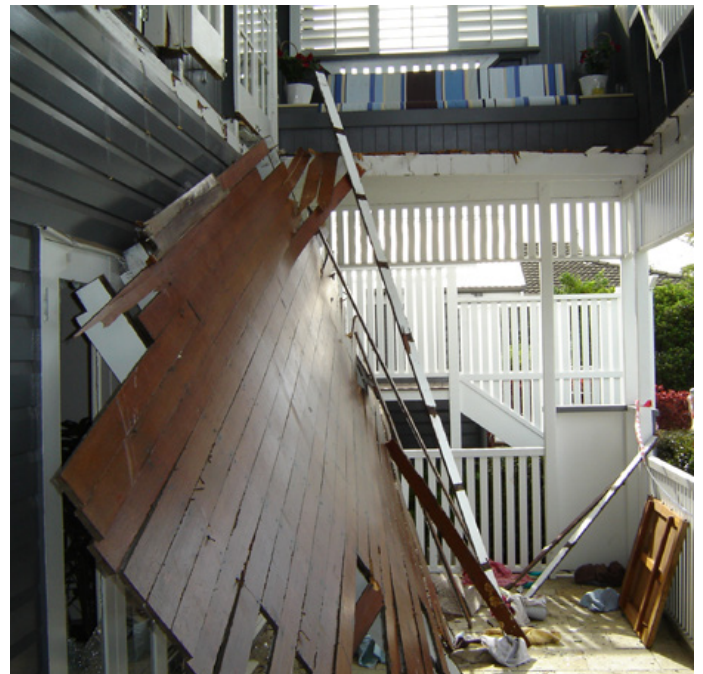
View of collapsed deck

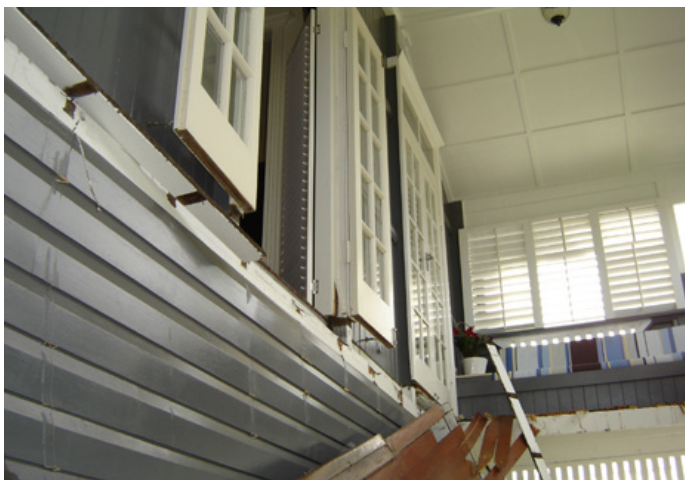
View of internal bearer support at external wall of home

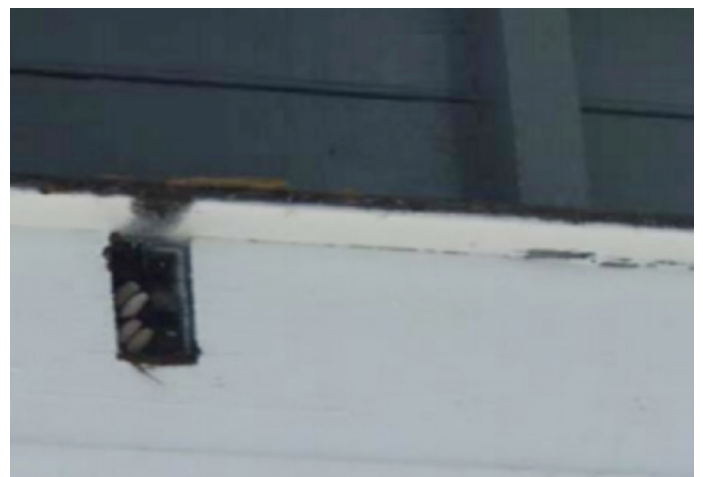
Mud wasp nests in the bearer housing is evidence that a sizeable gap existed where the floor joist cog was not fully engaged into the bearer

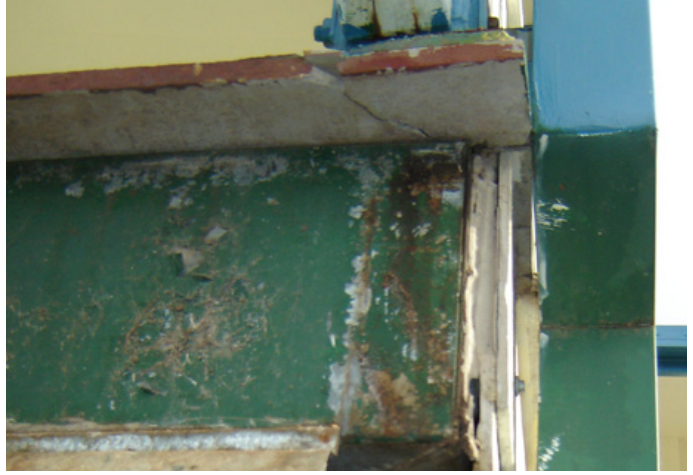
Cause of collapse - It appears that the south-west corner of the deck failed initially where the deck bearer was attached to the main dwelling. It was further found that the deck bearer that failed penetrated the external cladding boards and relied upon support by multiple pine corner wall studs in the wall cavity. The pine wall studs supporting the bearer were found to be totally rotted out due to the ingress of water into the wall frame.

Support point for the bearer

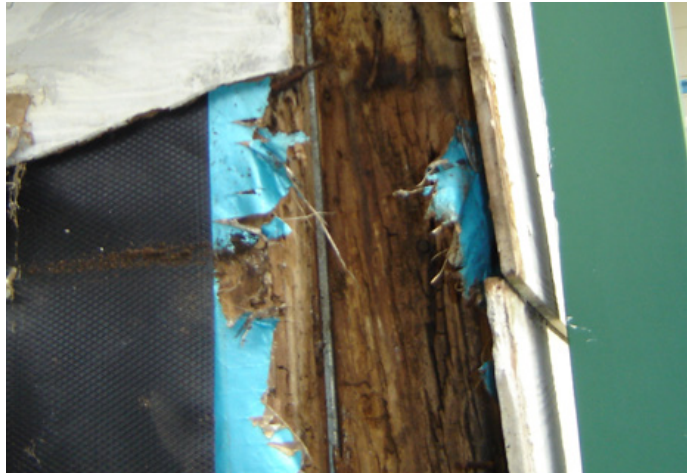
Rotted wall studs below the bearer support joint

Shrinkage/breakdown of the sealant over many years and some shrinkage of timber elements would have occurred, allowing water ingress and causing the decay to the non-durable pine studs in the enclosed wall.

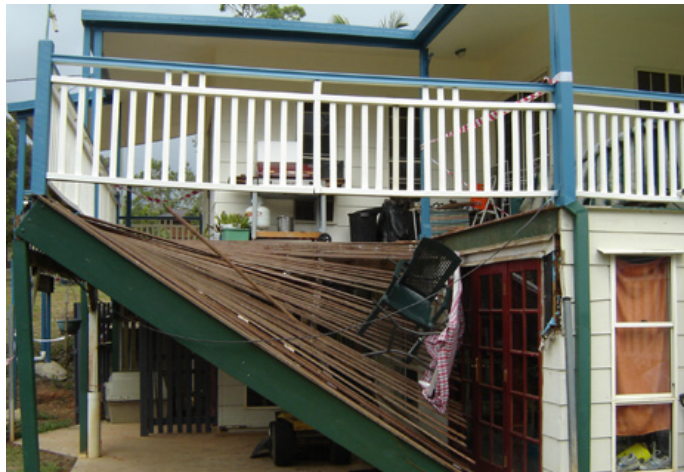
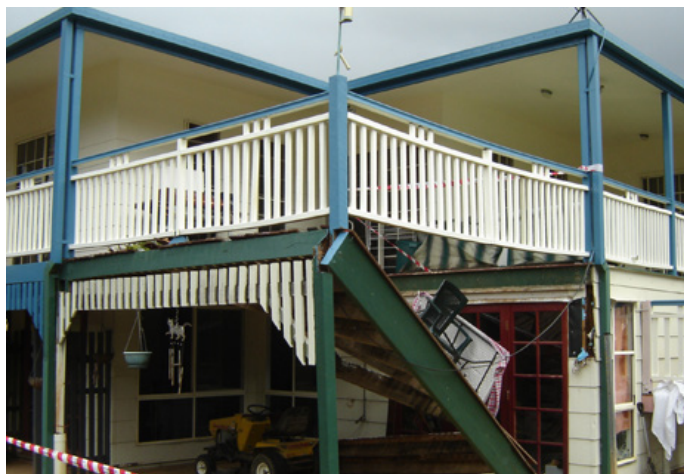
When a substantial load was applied to the deck in the direct vicinity of the south-west corner over the bearer being supported by rotted wall studs, the inadequate support allowed the bearer to rotate downwards and the collapse occurred.

Collapsed corner of the deck is clearly visible in these photographs

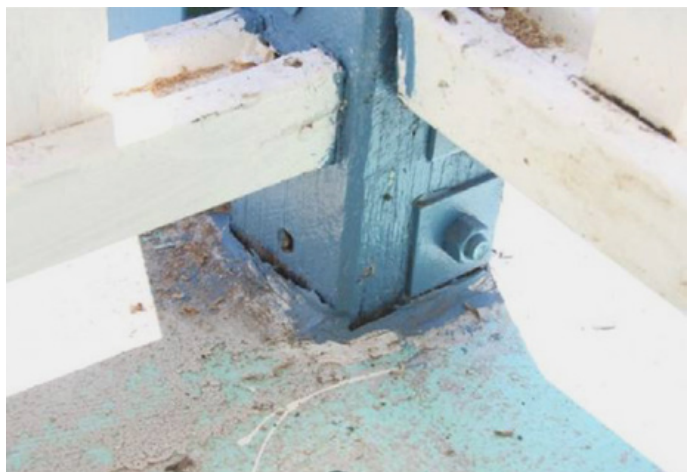
The ingress of water may have occurred where the bearer itself penetrated the wall cladding and also around the base of a timber veranda post of the main dwelling which was located directly above the location of the bearer. These points of water ingress relied solely upon sealant to prevent penetration of water.

Gaps around base of veranda post allow water ingress into wall cavity

- All structural framing members and their connections and support points below the floor level of structures such as decks, balconies and patios should be unenclosed and not sheeted to allow full visual inspection of those critical elements.
- When structural framing members and their connections and support points are enclosed and not visible for inspection, all framing and connections should be sufficiently durable to accommodate periodic wetting and drying. Alternatively, a method of inspecting the sub-structure to the deck and any building framing to which deck members are connected should be provided.
- No attachments to a dwelling such as patios, decks, balconies or the like should allow structural framing members to penetrate the external fabric of the main building unless the penetrations are flashed and sealed using permanent durable materials to prevent moisture entry.
